**DEBRIS/ICE/TPS ASSESSMENT and
INTEGRATED PHOTOGRAPHIC ANALYSIS
OF SHUTTLE MISSION STS-110**

Armando Oliu
Process Engineering/Mechanical System Division/ET-SRB Branch,
Kennedy Space Center, Florida

April 8, 2002

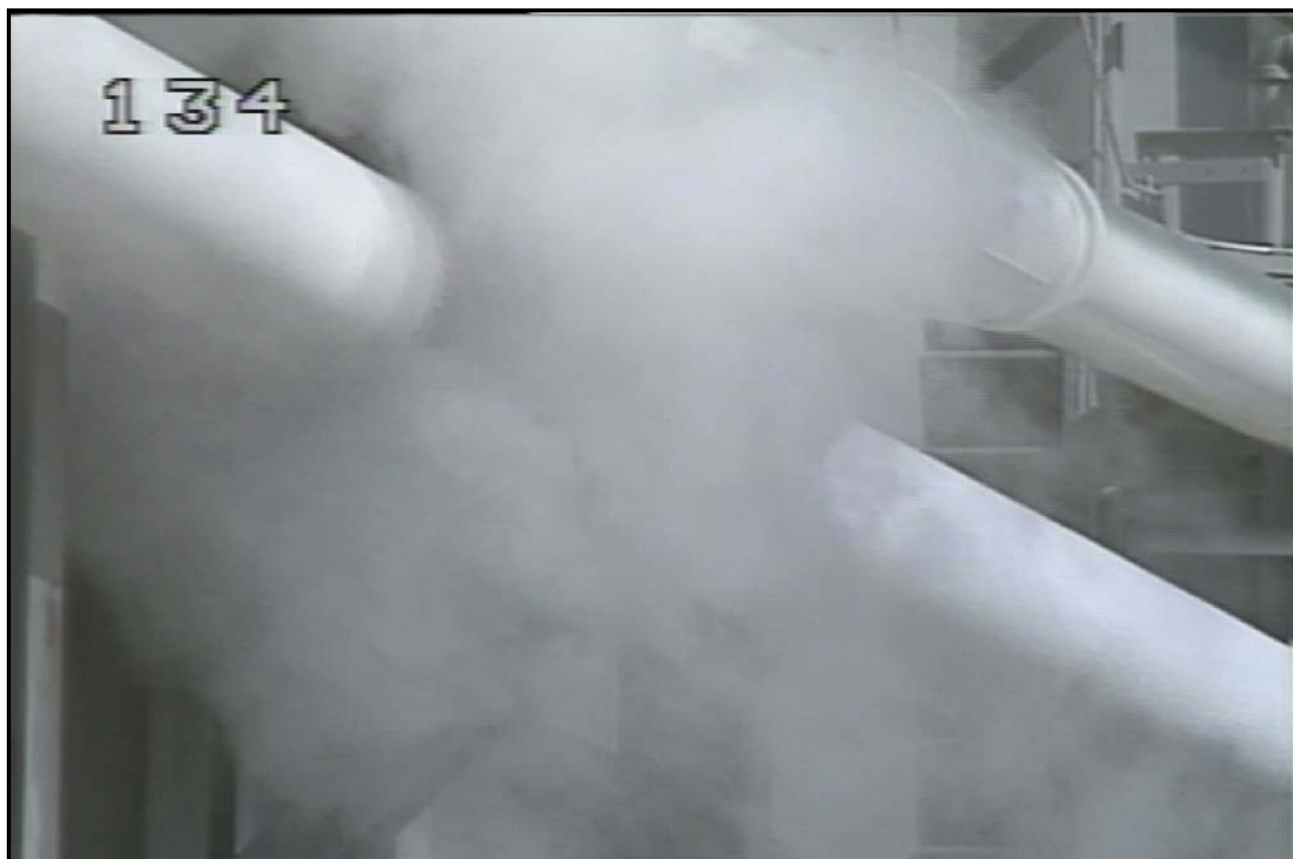
Photo 2: Hydrogen Leak in LH2 Vent Line.

Approximately 13 minutes into the LH2 fast fill portion of the ET loading a large vapor cloud was detected on MLP Side 4 using the OTV system. A 16-inch MLP hydrogen vent line was identified as the origin of the leak. ET loading was halted and a drain initiated. The ET was only partially loaded. No anomalies had been detected, via OTV, on the ET during the loading process. The loading of cryogenics into the ET began at approximately 6:17 am on halted after a leak was detected on a LH2 line on the MLP.

This attempt to launch STS-110 was scrubbed due to the hydrogen leak on the LH2 vent line on the MLP.

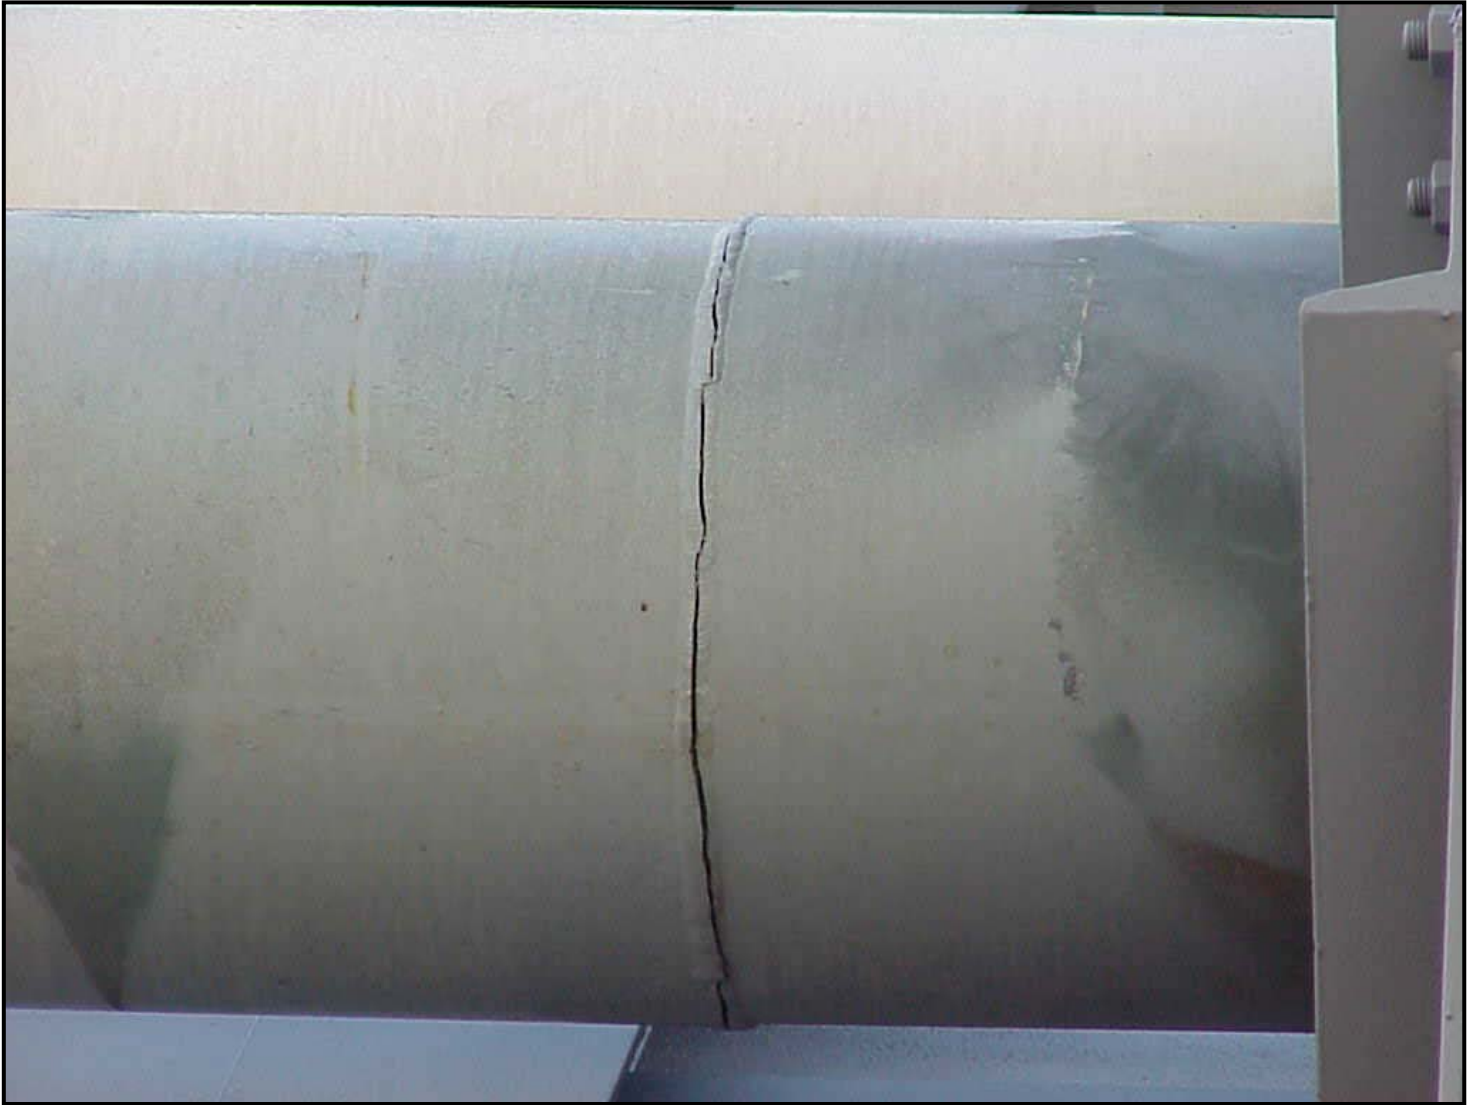
Photo 3: Crack in Hydrogen Vent line on MLP.

The post drain inspection of STS-110, MLP-3, and Pad B FSS was conducted on April 4, 2002 from 1230 to 1330 hours. The launch scrub was called at 0927 hours due to a massive hydrogen leak on the hydrogen vent line running along the MLP east side. The team performed a preliminary inspection of this line from the pad surface using binoculars. An approximately 1/8 inch wide crack was observed at the leak location.

In summary, no IPR conditions and no flight hardware concerns were detected during the post drain inspection. Other than the Hydrogen Vent line crack there are no constraints for the next cryoload.

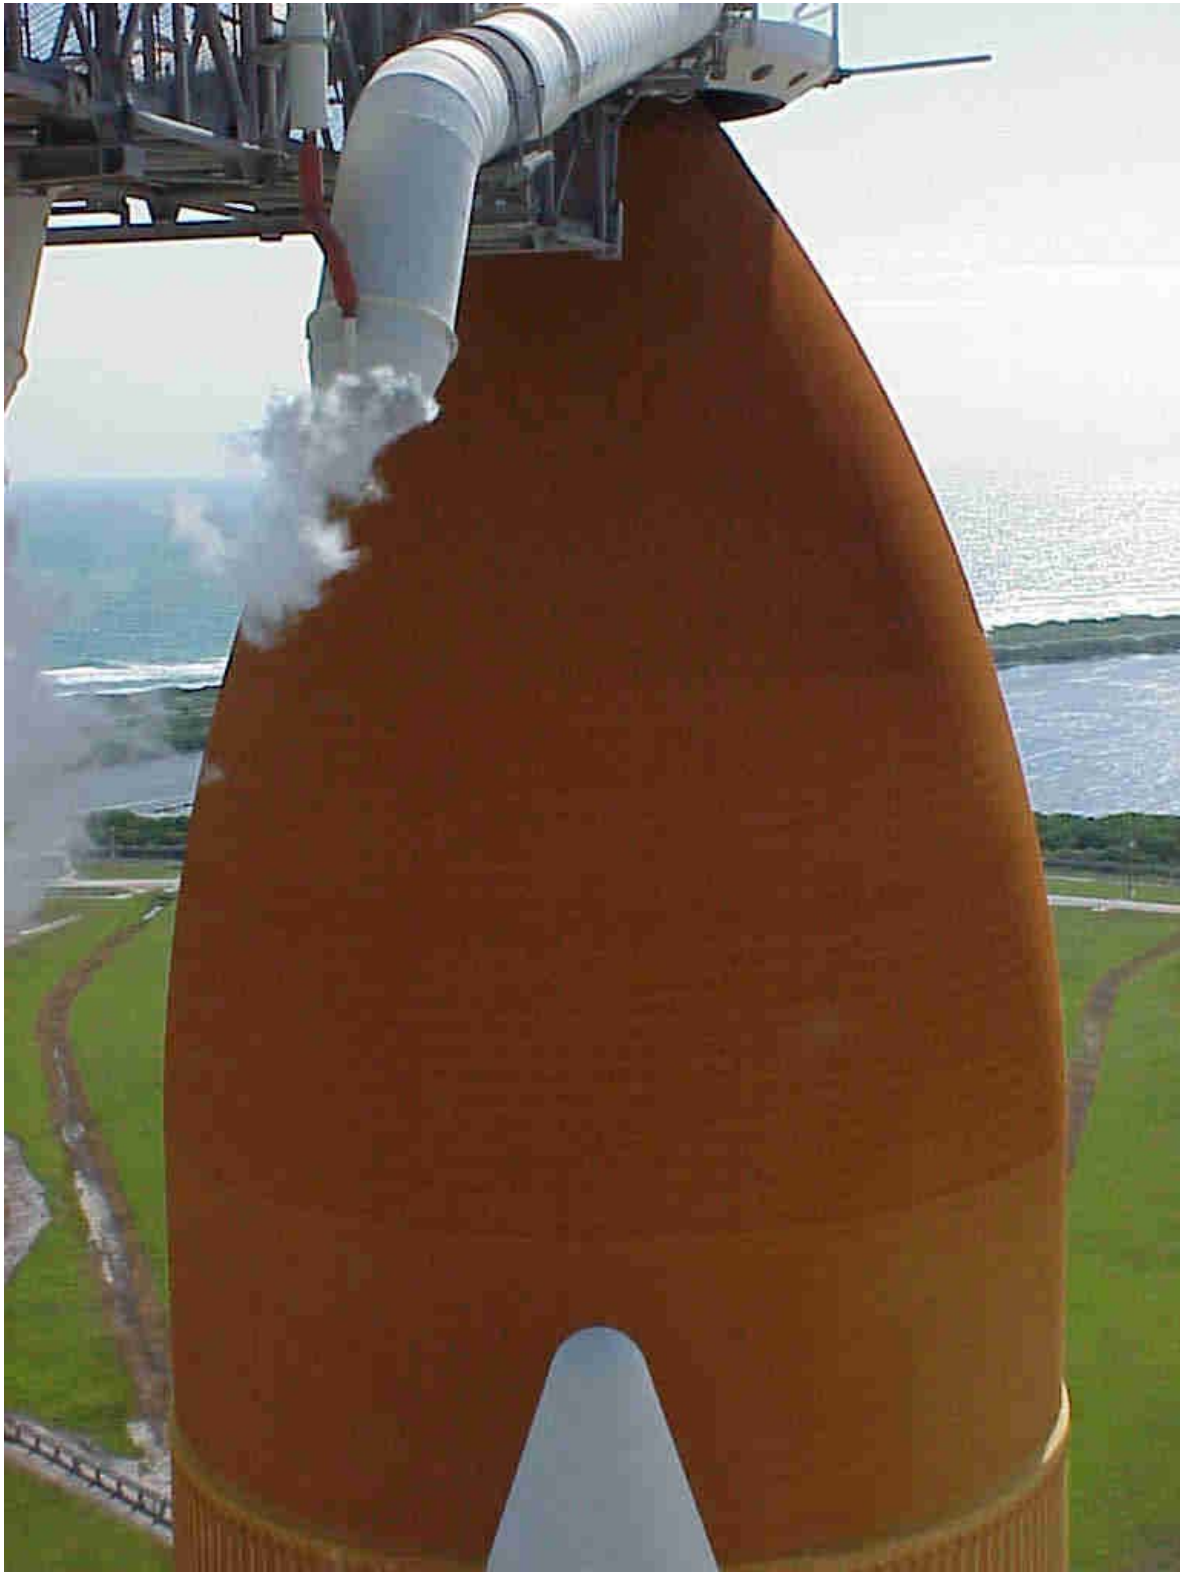
Photo 4: LO2 tank acreage.

No condensate was present on the LO2 tank acreage. Surface temperature ranged from 58-72 degrees Fahrenheit. There were no acreage TPS anomalies.

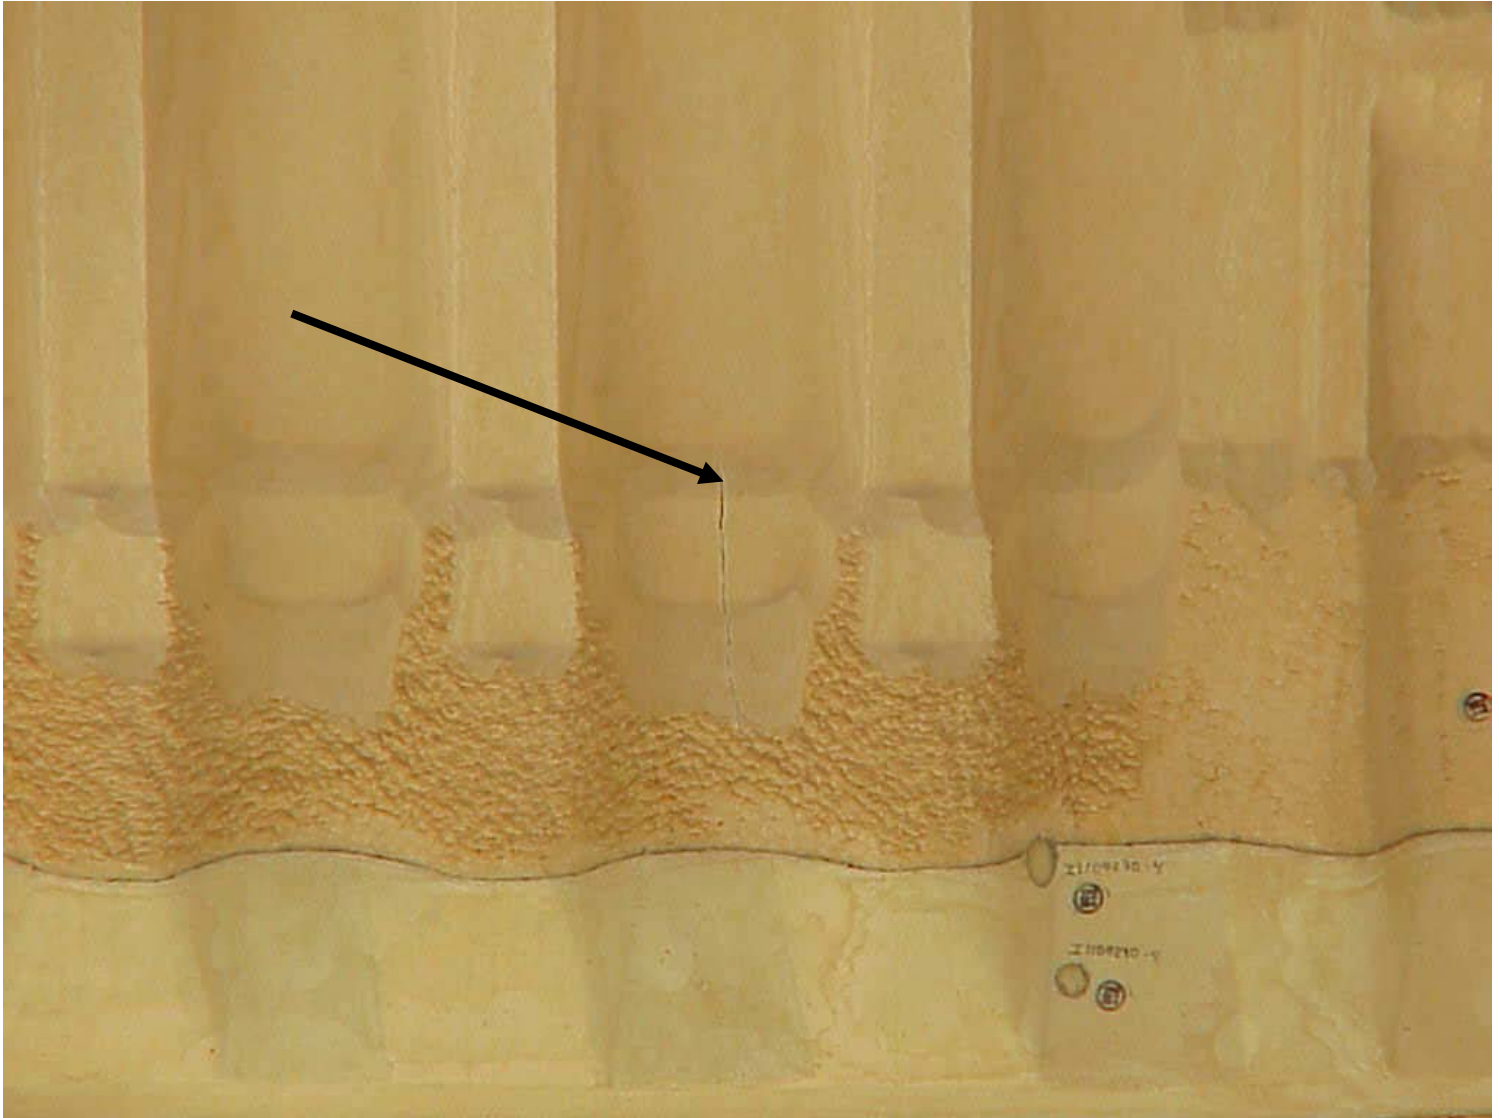
Photo 6: Crack in Intertank Valley

No significant anomalies were present in the intertank TPS. Four cracks in the intertank stringer valley TPS were observed (1st valley -Z of -Y thrust panel, 1st valley +Z of -Y thrust panel, 1st valley -Z of +Y thrust panel, and 2nd valley +Y of the LH2 PAL ramp). The cracks exhibited no ice, frost, or offset. Therefore, the cracks were acceptable for flight per the NSTS-08303 criteria. Ice and frost accumulations on the GUCP were typical.

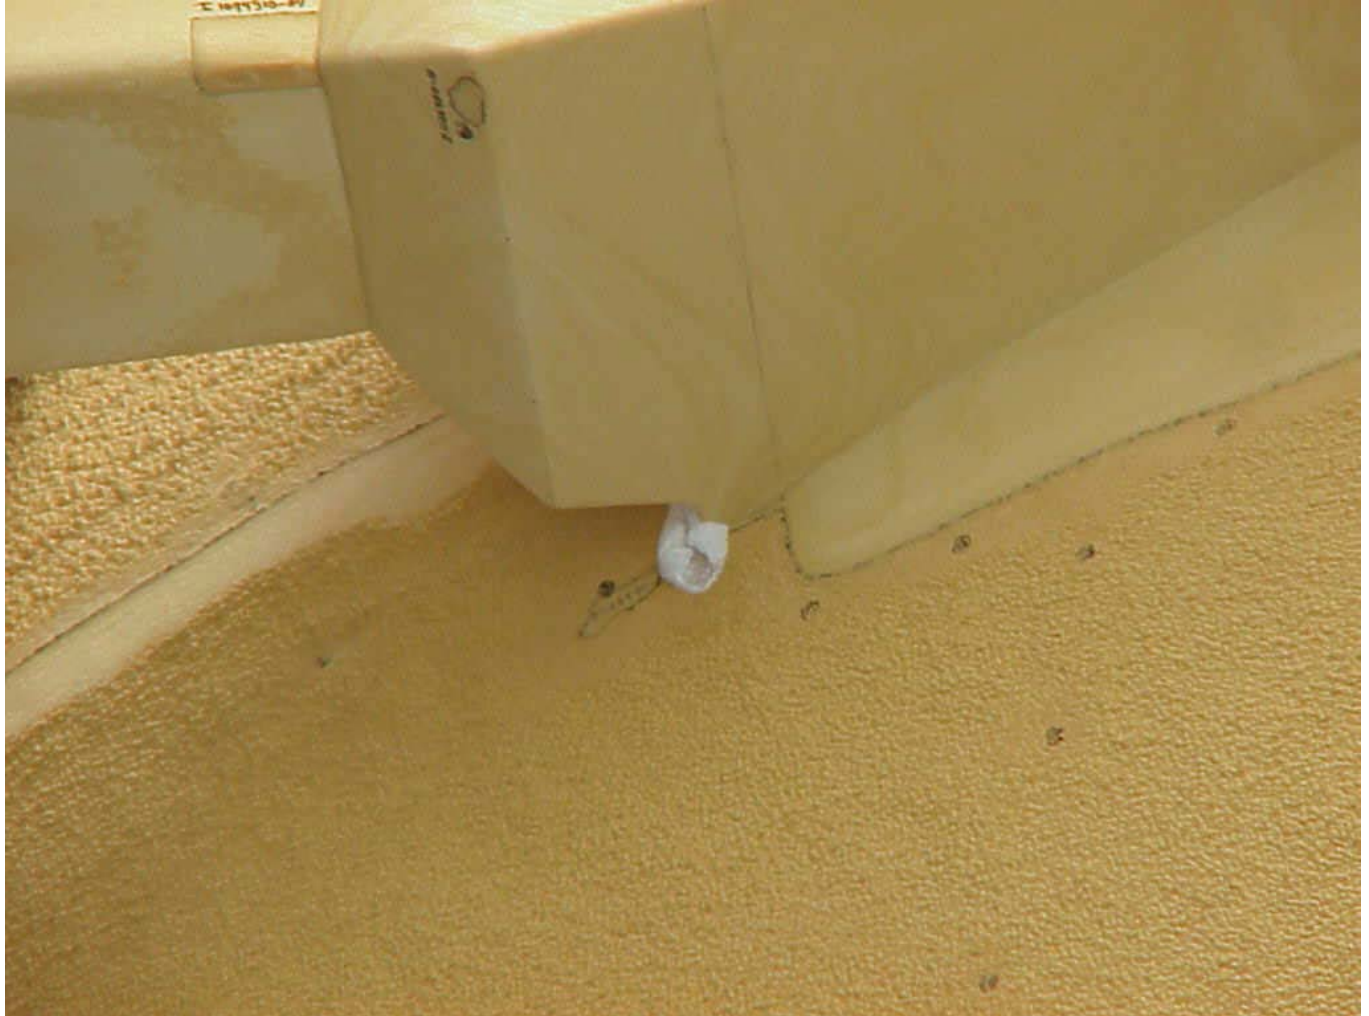
Photo 7: Frost ball.

2-inch diameter frost spot on the aft side of the +Y vertical strut to LH2 tank interface.

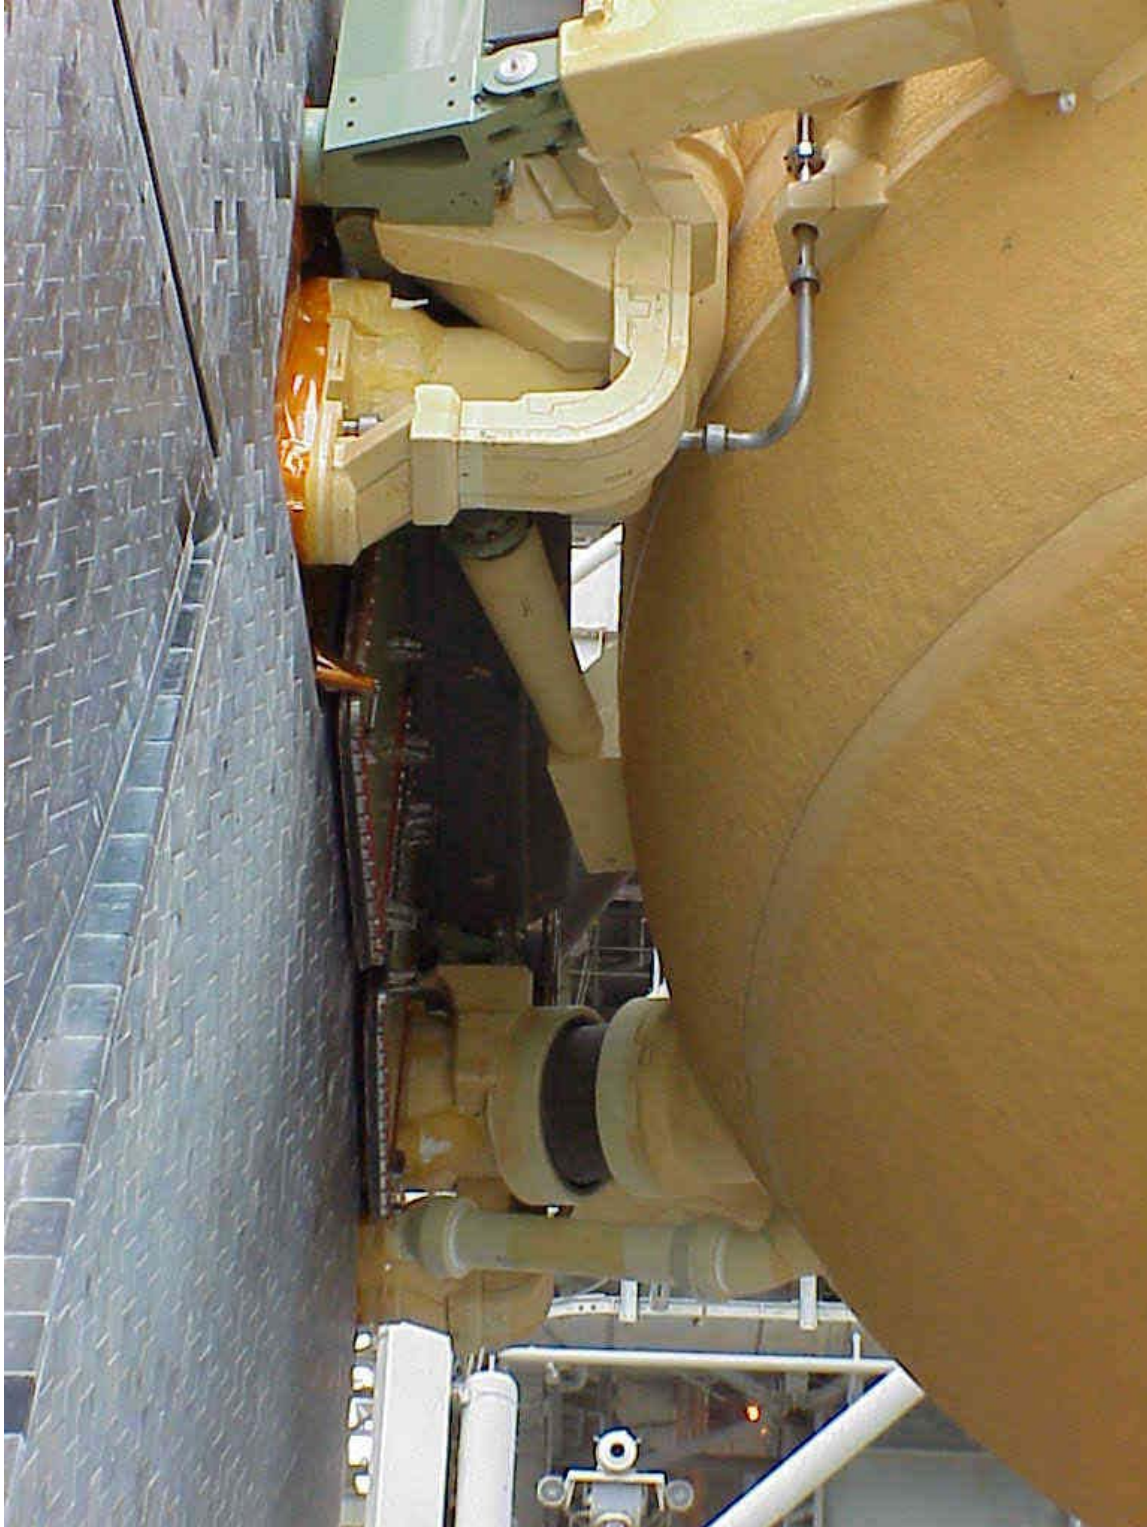
Photo 8: Umbilical area.

Typical ice/frost finger on pyro canister vent and on LH2 recirculation line bellows.

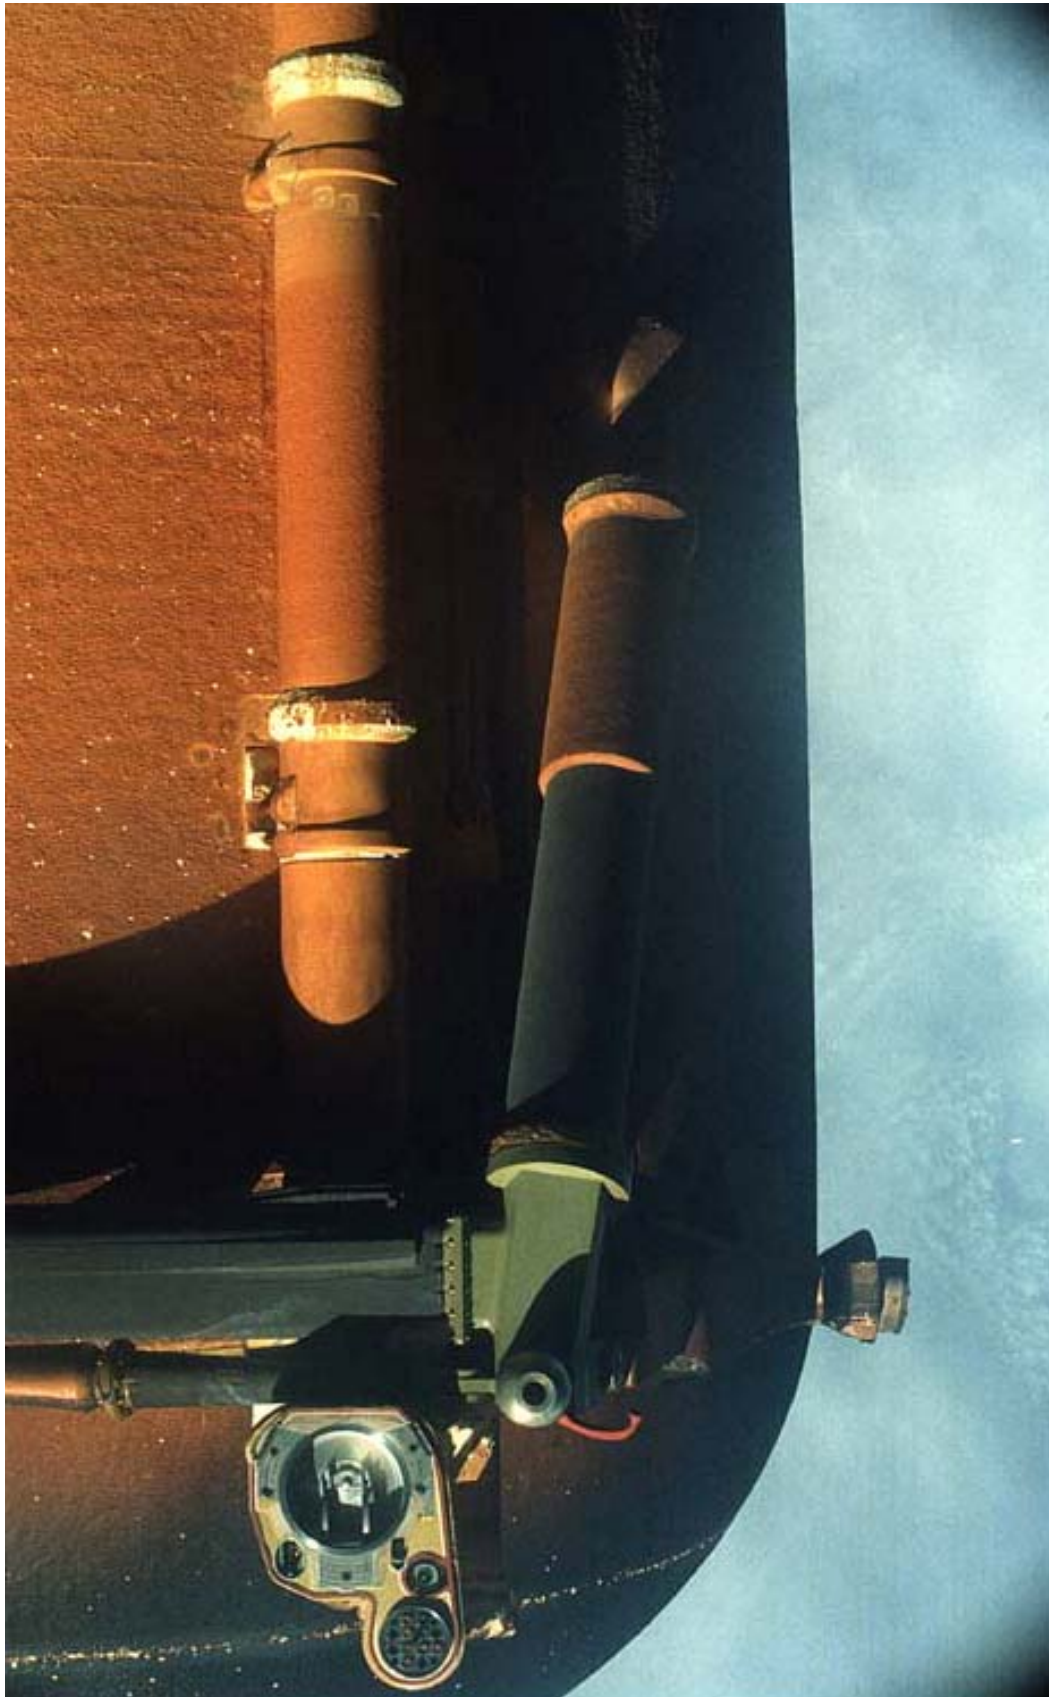
Photo 9: ET Post Separation.

The ablation/erosion of LO2 feedline flange closeouts was typical.

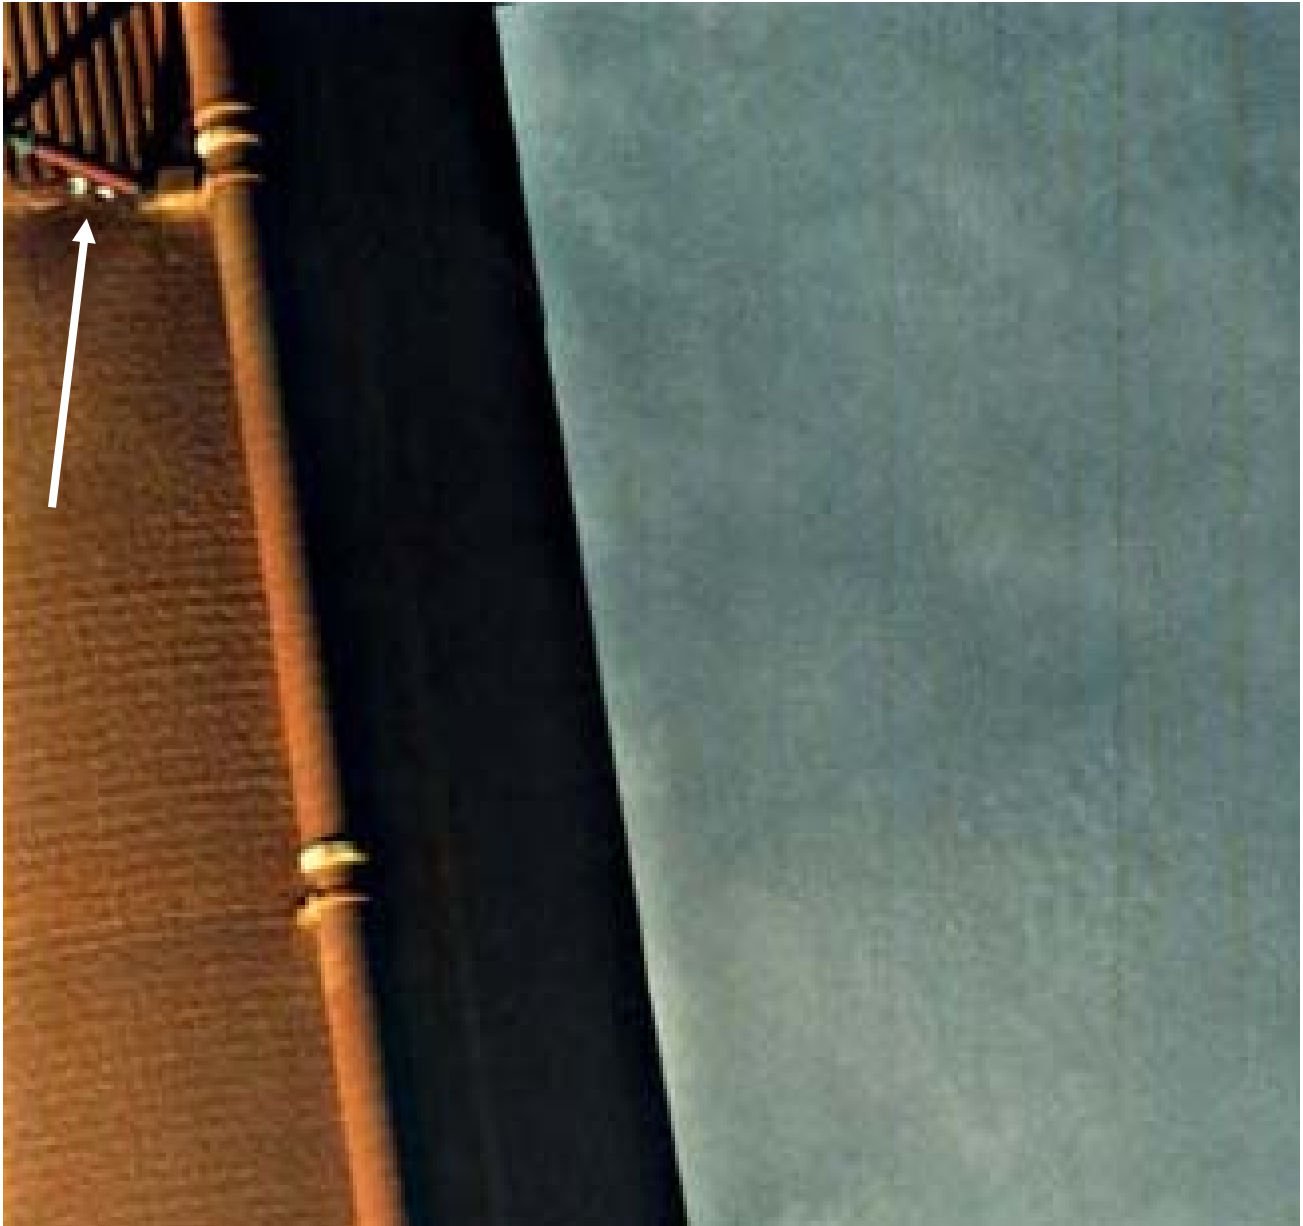
Photo 10: ET Post Separation.

Two divots, approximately 5 inches by 5 inches, were observed on the intertank-to-LH2 tank flange closeouts between the bipods. One of the divots encompasses a significant portion of the +Y Jack Pad closeout.

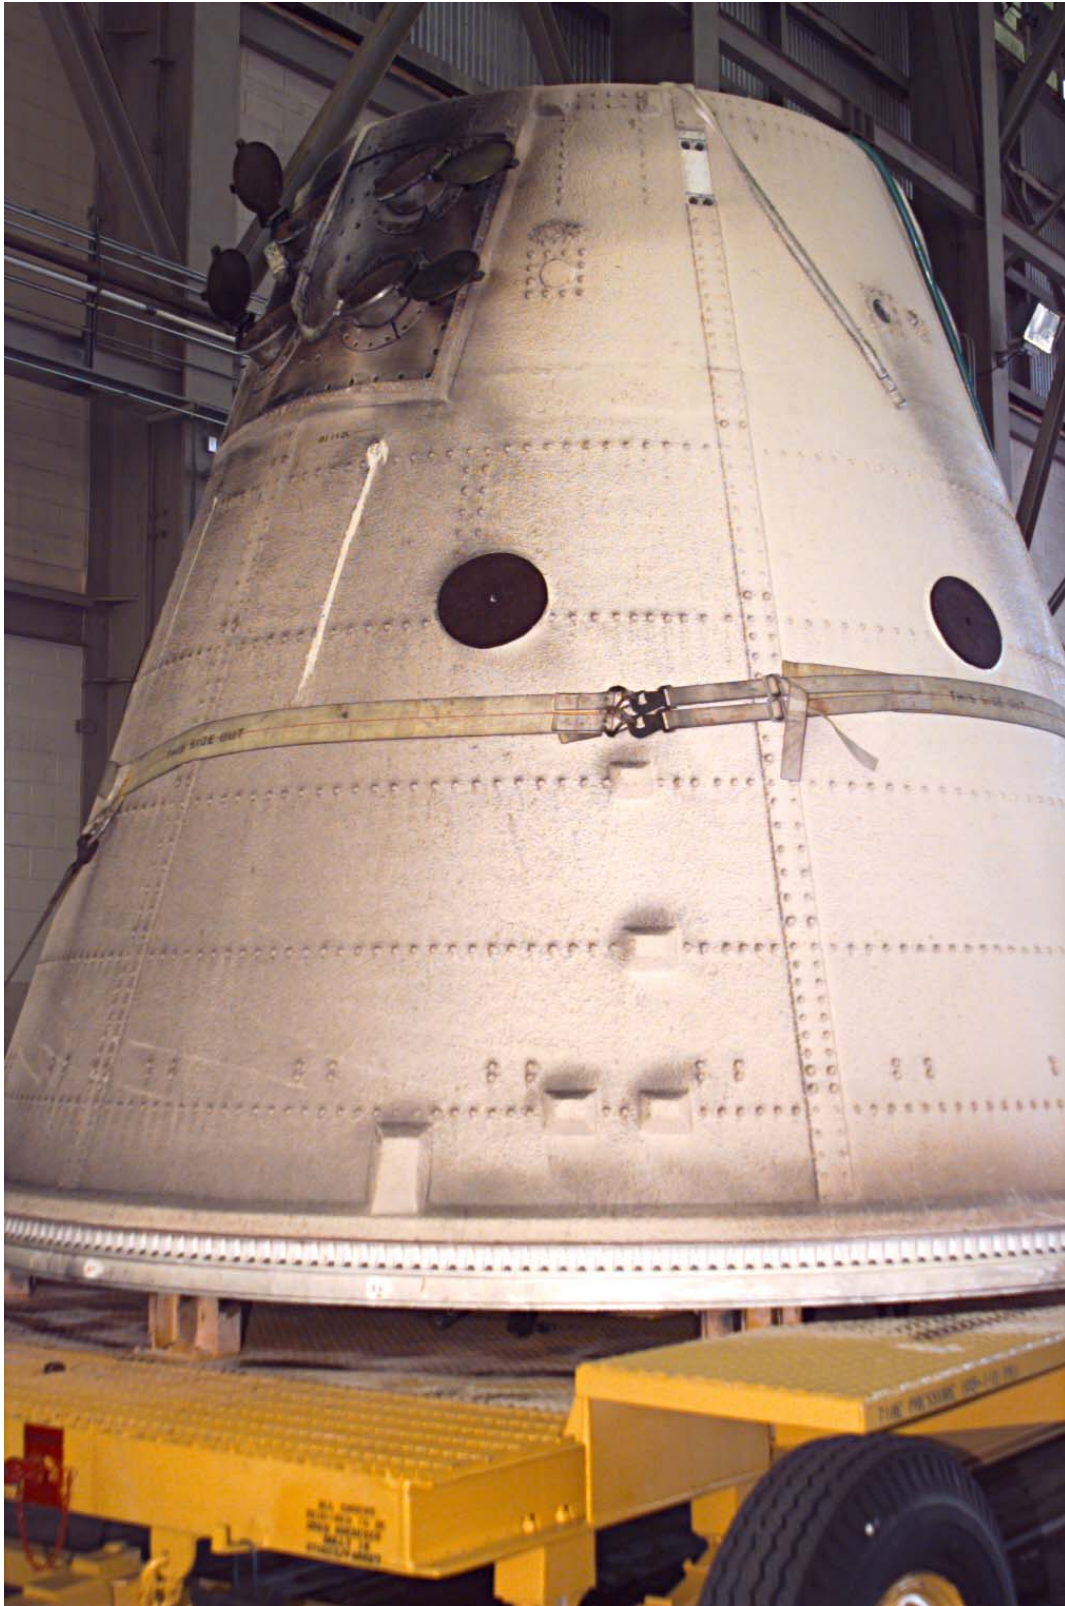
Photo 11: LH Frustum Post Flight Condition

The LH SRB frustum exhibited no debonds/unbonds or missing TPS.

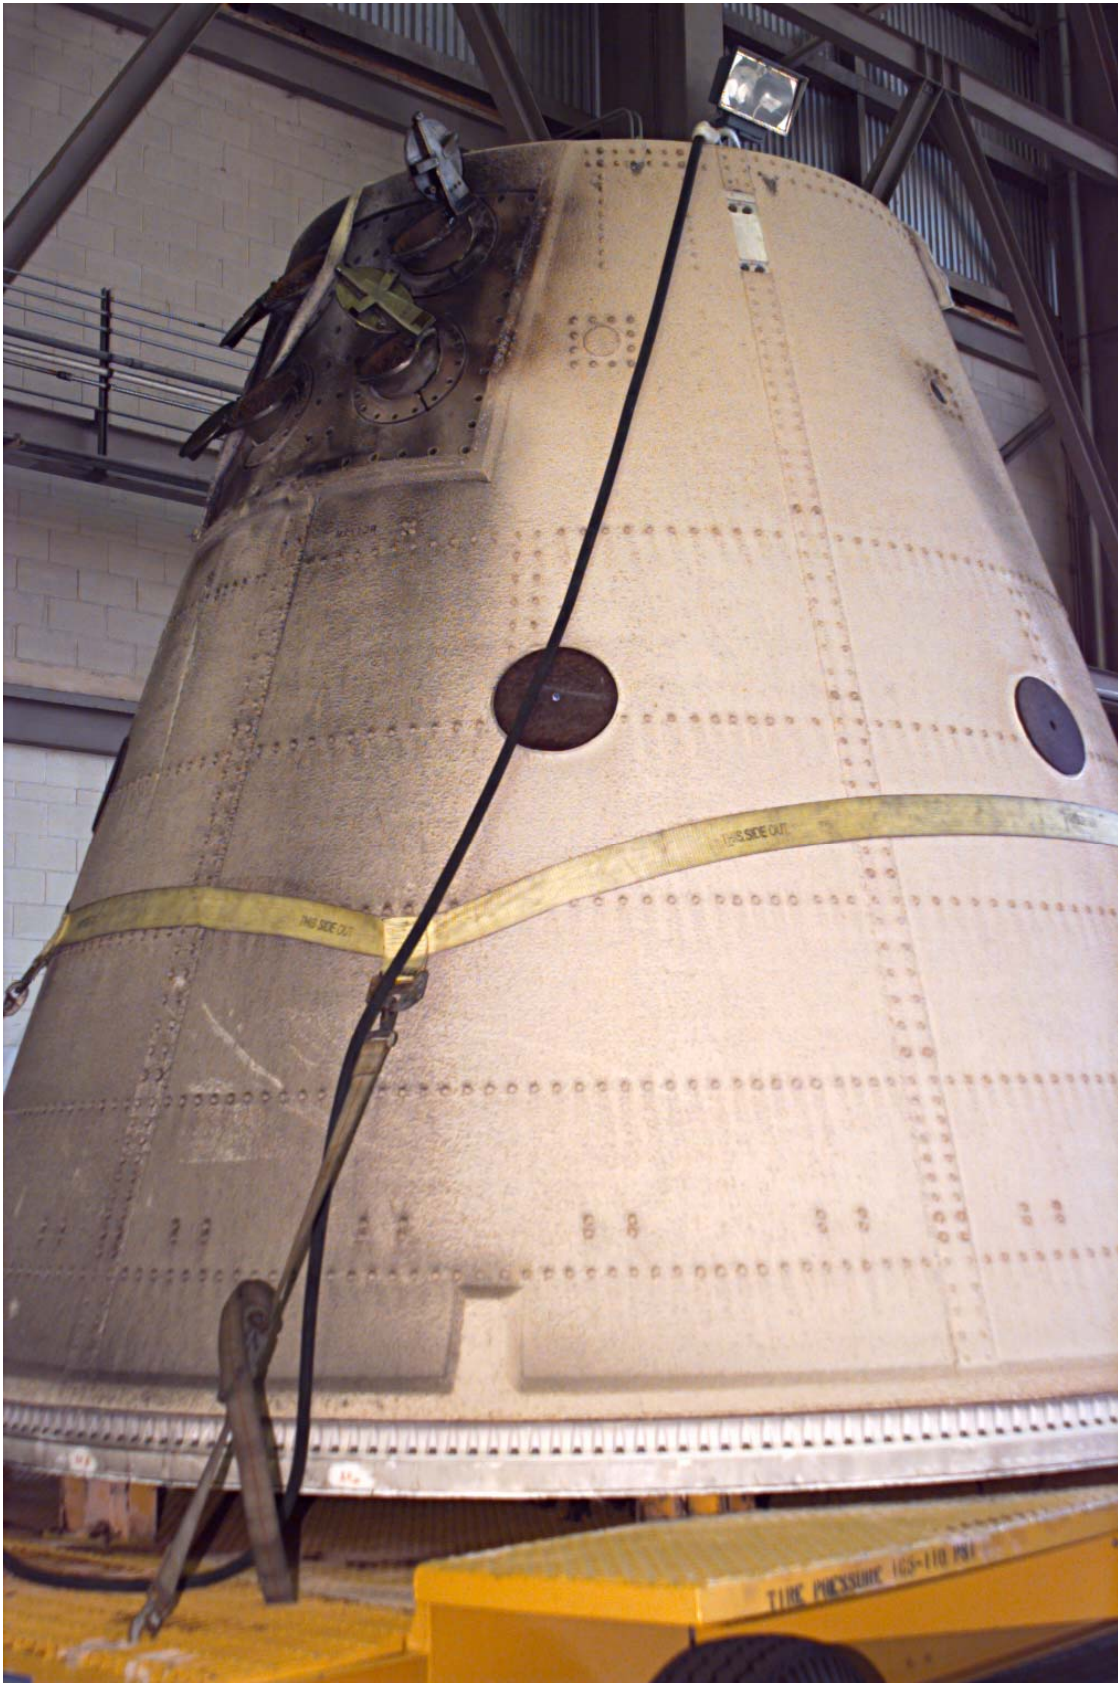
Photo 12: RH Frustum Post Flight Condition

The RH SRB frustum exhibited no debonds/unbonds or missing TPS.

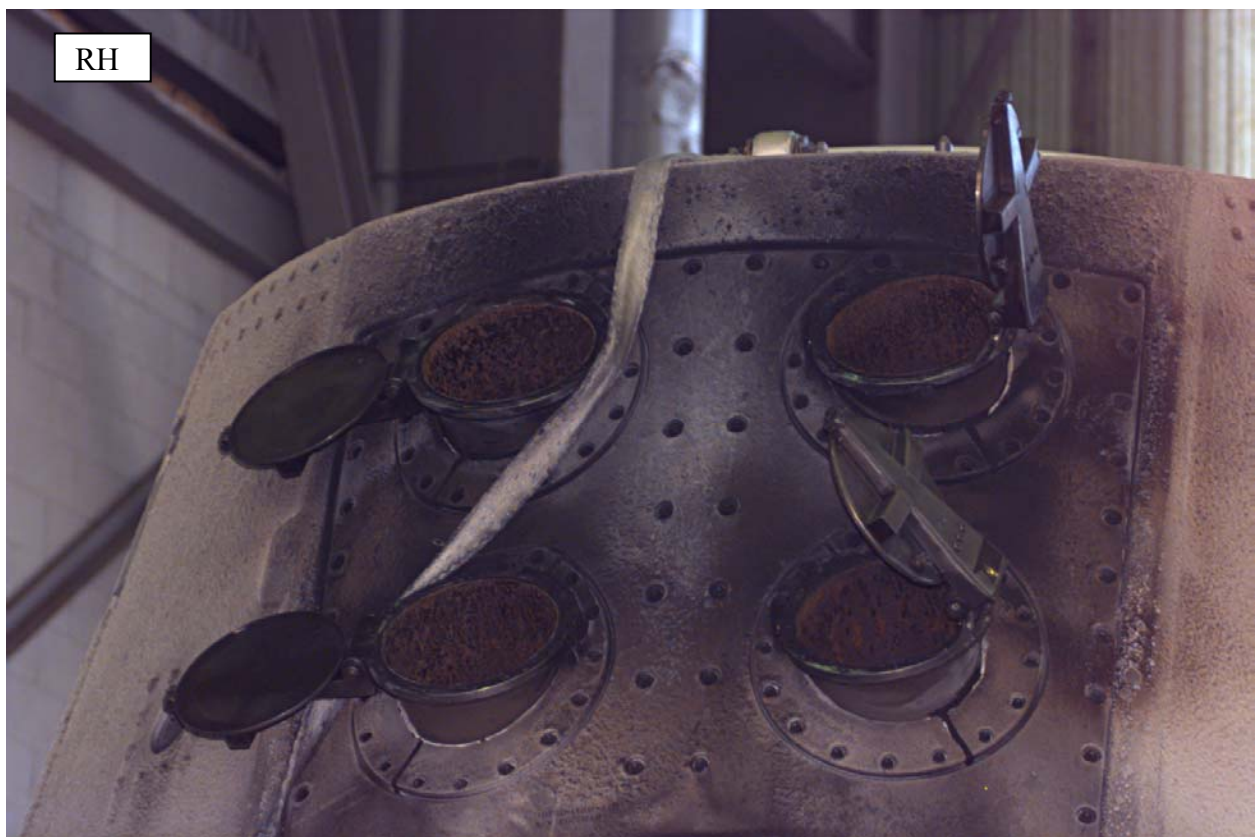
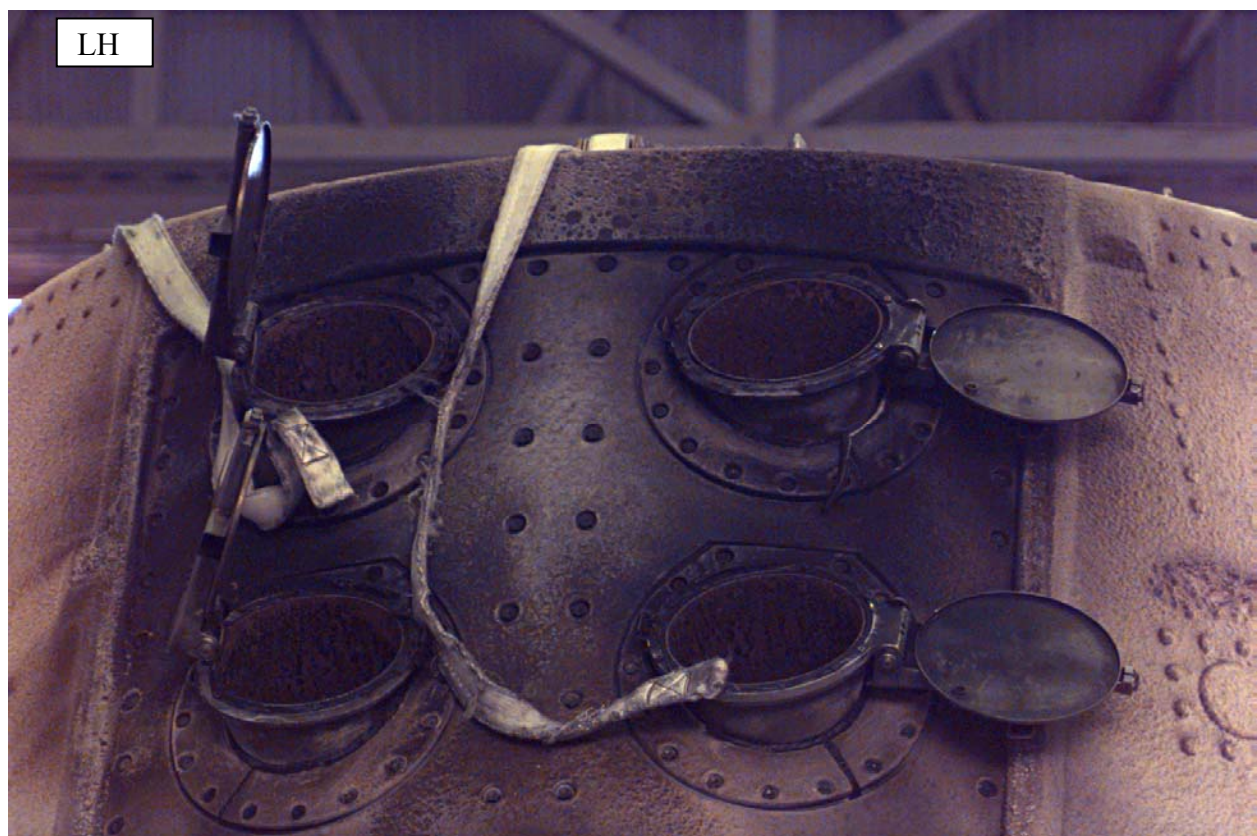
Photo 13: BSM Cover Condition

Two RH and two LH cover attach rings had been bent at the hinge by parachute riser entanglement.

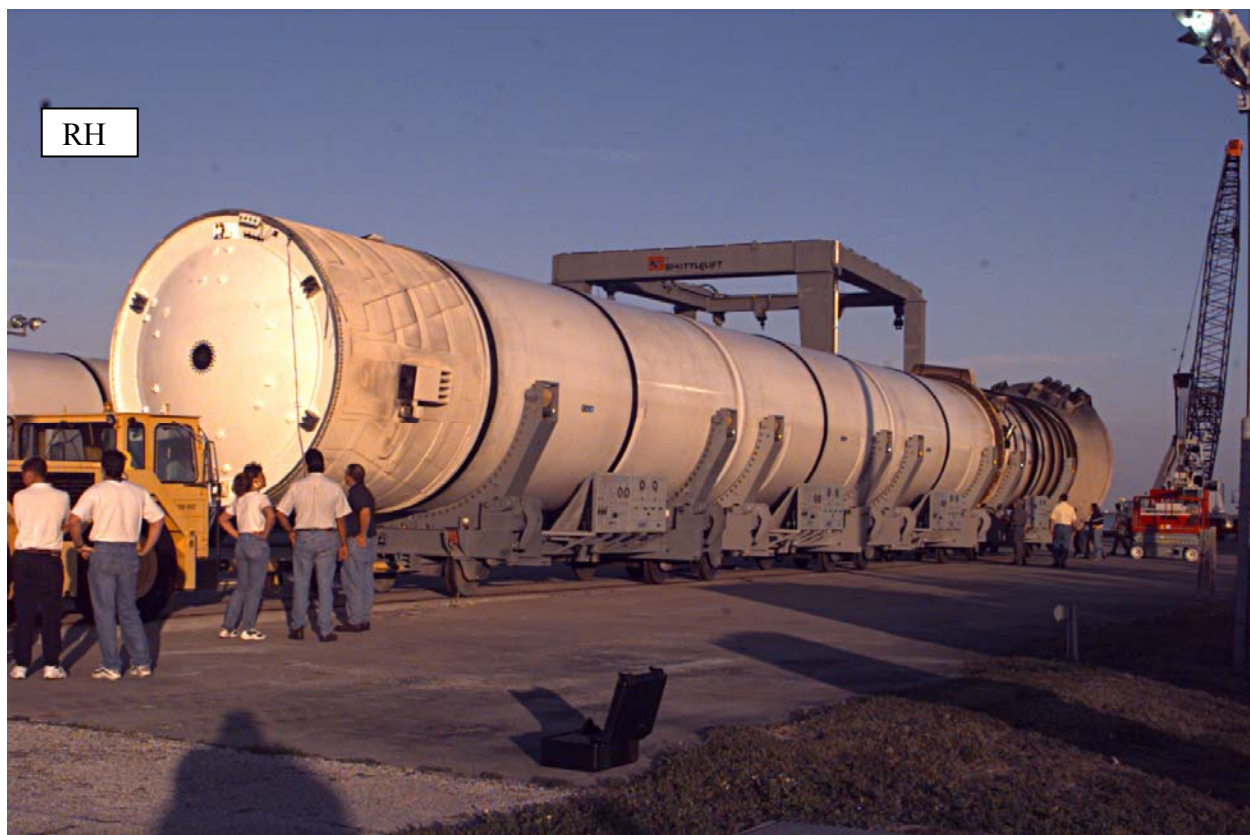
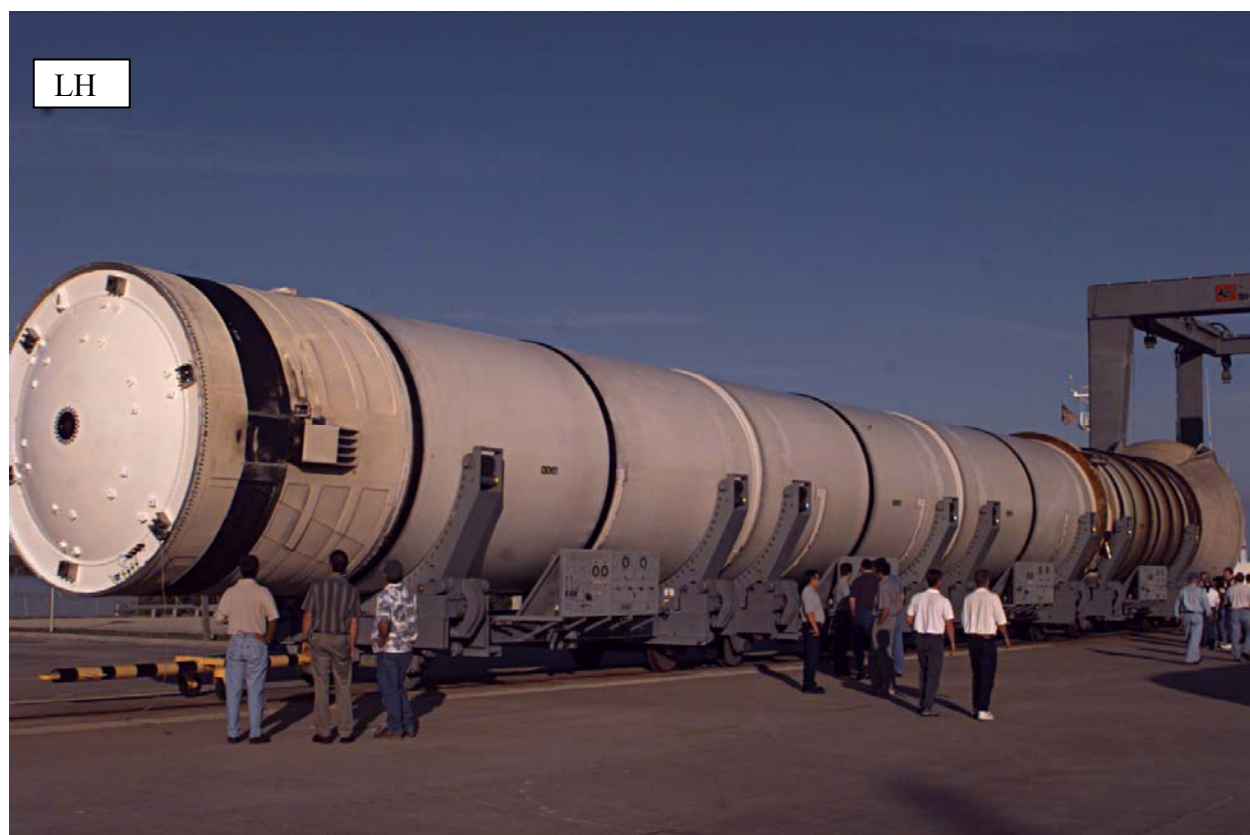
Photo 14: SRB Post Flight Condition

Both SRB's were found in good condition regarding debris assessment
